# Cover Page

On-Site Property (Facility) Name: Former F.J. Doyle Transformer Salvage/Recycling Facility  
Street no. 905 Pre dir: N. Street name: Poplar Street type: St Post dir: \_\_\_\_\_  
City: Leonard County: Fannin County Code \_\_\_\_\_ Zip 75452  
Nearest street intersection and location description: 0.344 acres, SW Corner of N. Poplar St and E. Cottonwood St  
Latitude: Decimal Degrees (indicate one) North 33.389437  
Longitude: Decimal Degrees (indicate one) West 96.243147

***Figure A - Affected Property and PCLE Zone Map***

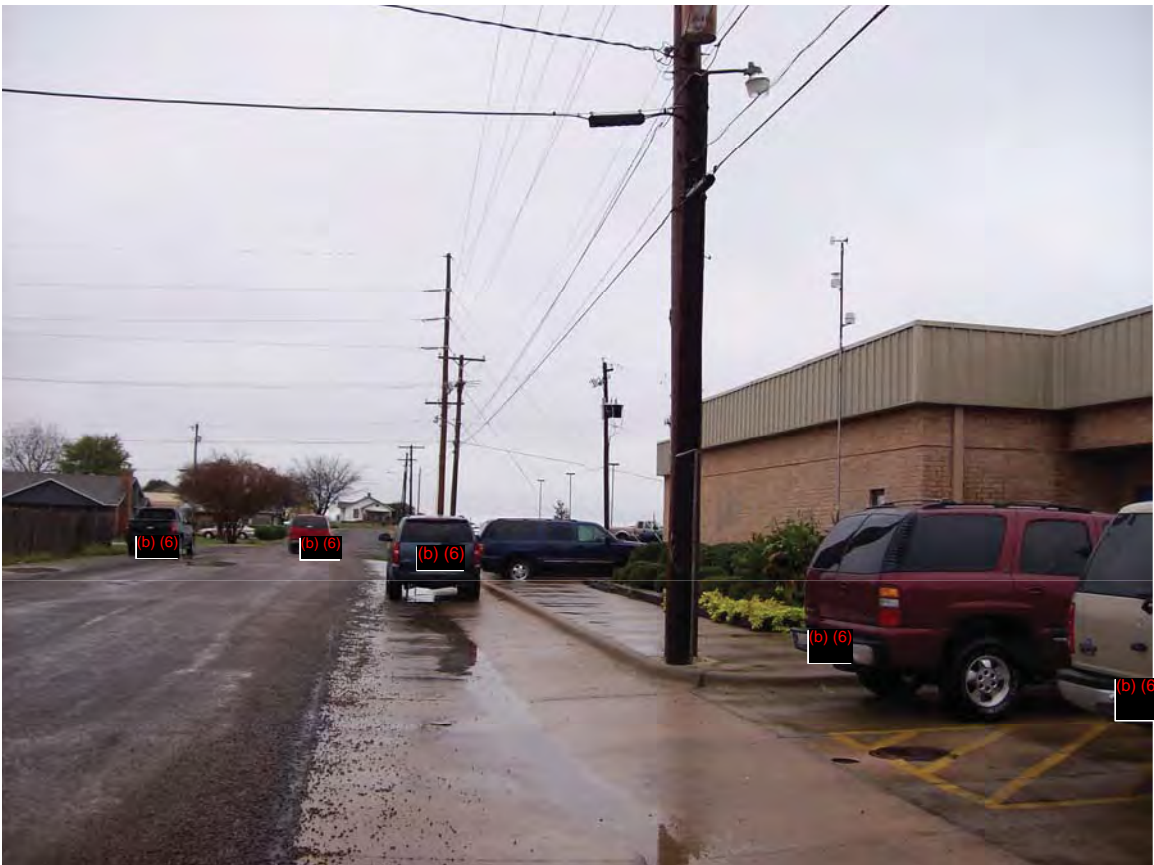
Photograph 6: View looking north along N. Poplar Street showing the school buildings east of the site. Also note the one transformed on the power pole in the foreground (#N6497) and in the three in the background (Nos. N23508, N21884, and N21888).

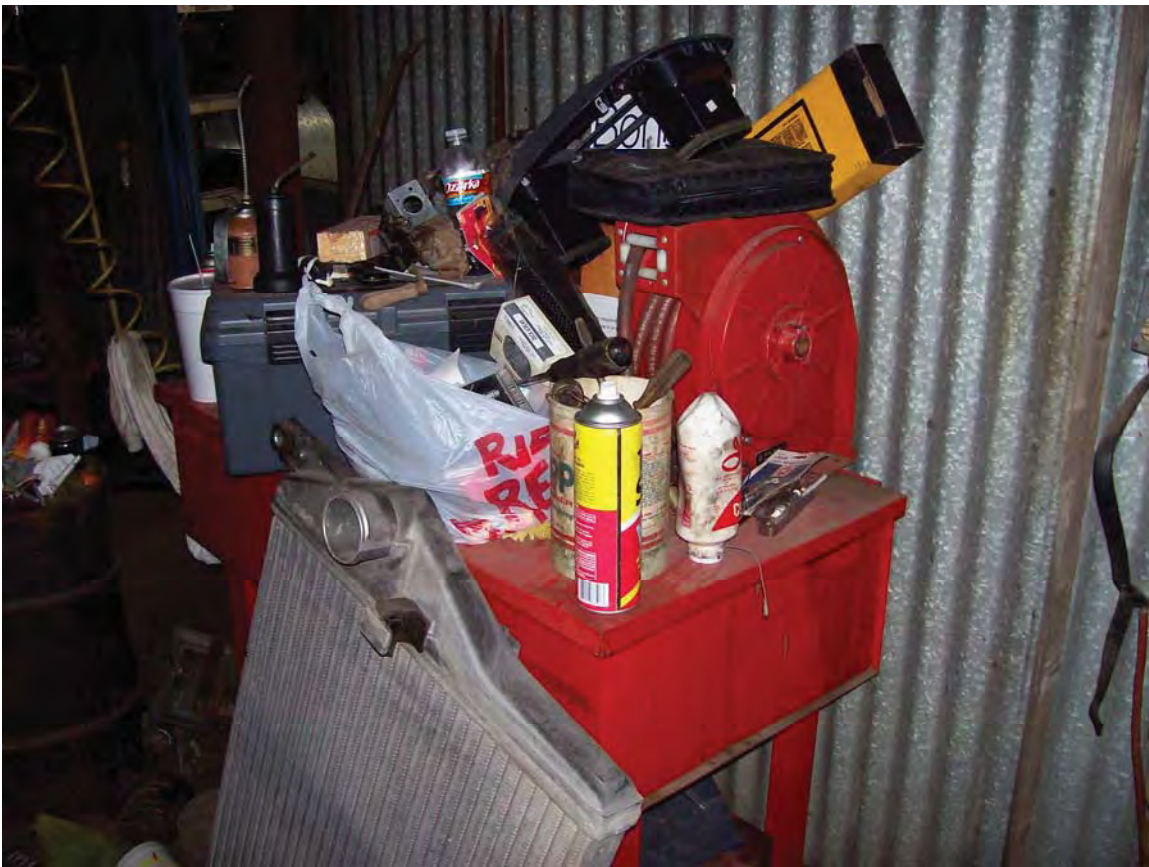
Photograph 9: View inside the shop building showing the parts washer and other chemicals.

- Terra-Solve observed a solvent parts washer in the warehouse repair area. The warehouse and office storeroom also store various amounts of general cleaning and general maintenance supplies.

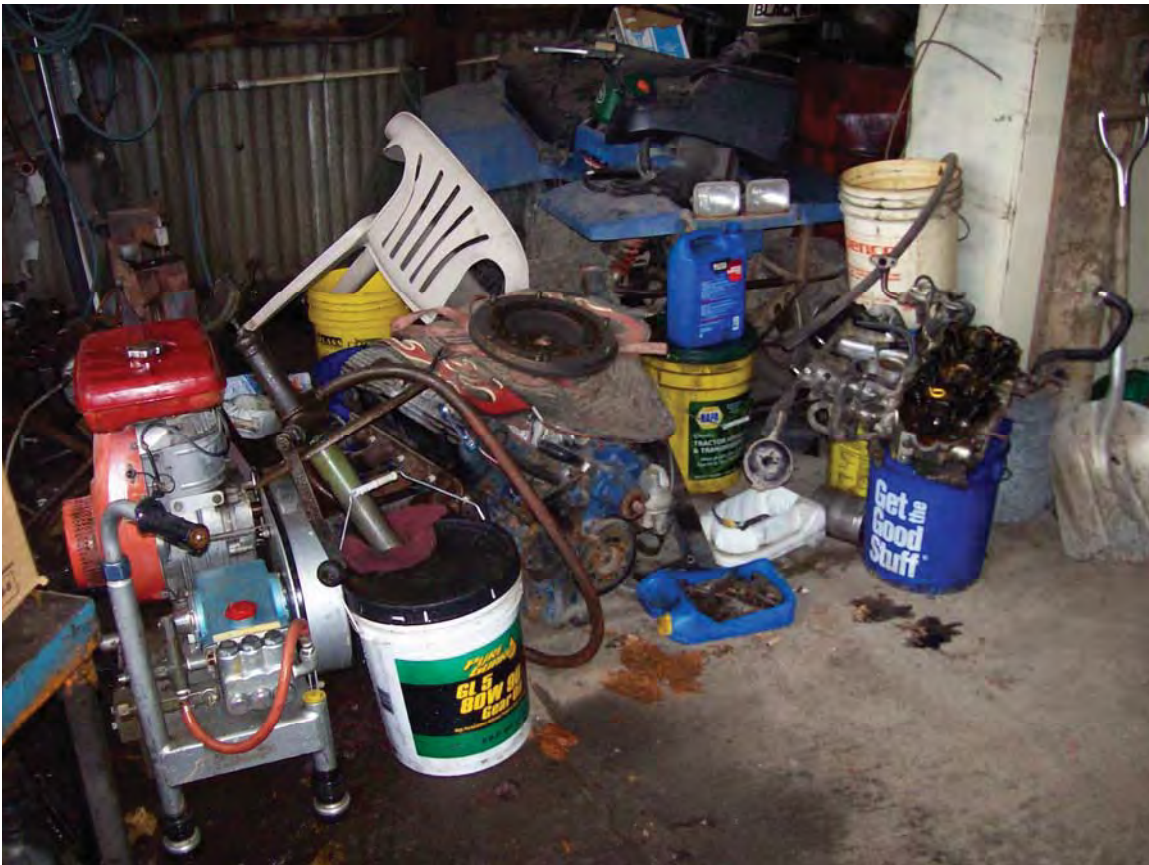
Photograph 10: View inside the shop building showing 5-gallon buckets of chemicals and oil, both new and used. Numerous areas of stained concrete are visible in the shop.

- Numerous areas of oil staining were observed on the concrete inside the shop building and staining was observed near the secondary containment basin and hydrocarbon sheens were observed in the parking lot.

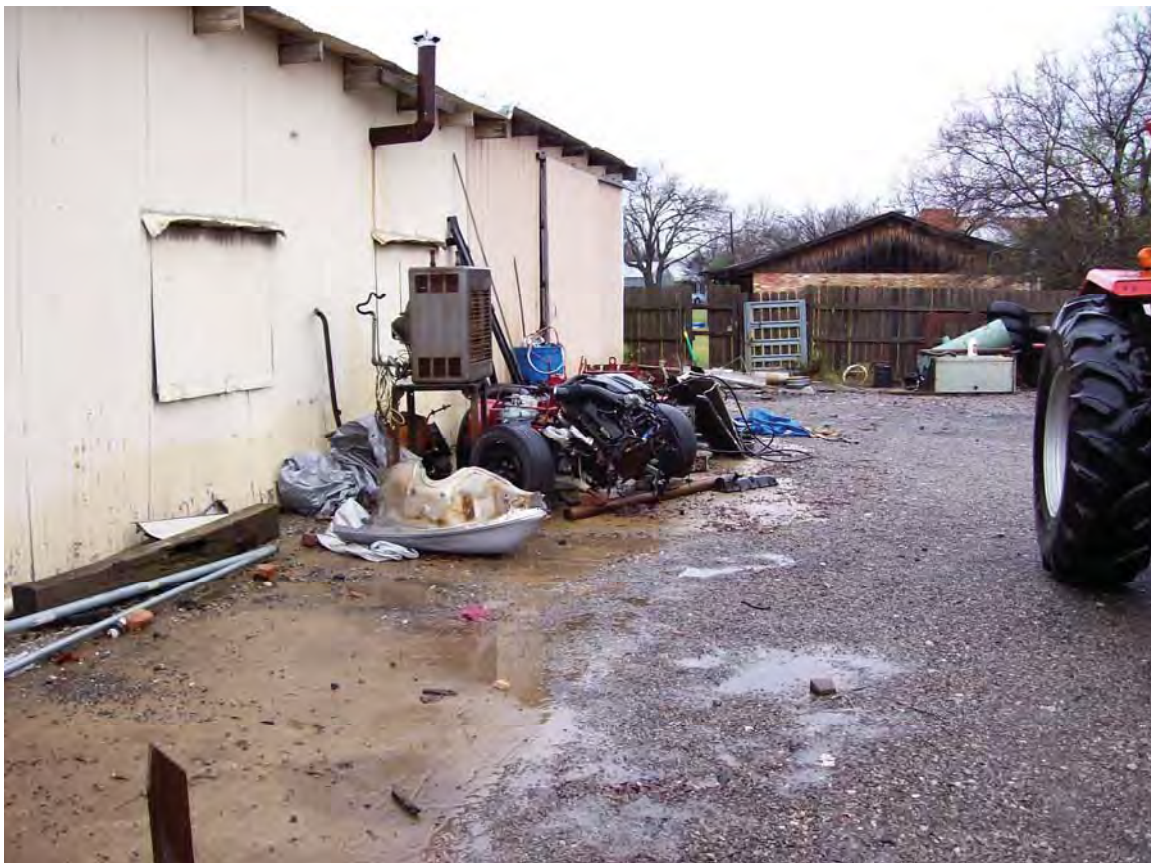
Photograph 16: View looking southwest of the north side of the shop building showing some of the scattered areas of debris and parts.

- Terra-Solve observed numerous unidentified containers on the property, mostly inside and near the shop building and on-site trash cans for authorized disposal. However, a large amount of debris and parts are stored on site.
